**Bureau of Design  
Engineering Computing Management Division**

<p><b>BRADD</b> No. 019 October 31, 2008</p>	<p><b>Incorrect Abutment 2 Bearing Seat Offsets for Box Beam Bridges</b></p>
--	--

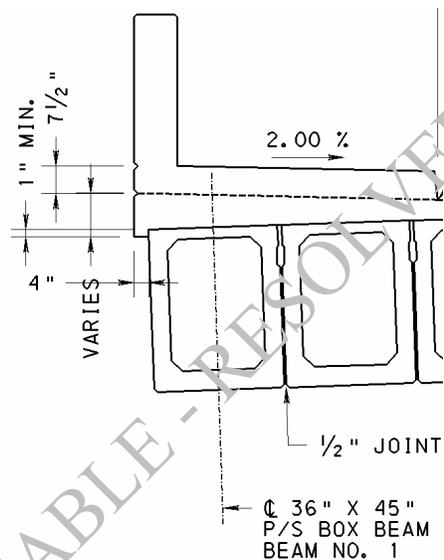
The problem occurs as BRADD computes the horizontal distance between the location of the top and bottom of the centerline of the box beam due to the transverse slope of the beam. In the figure shown below, the bottom of the centerline of the box beam is shifted to the right due to the transverse beam slope. BRADD incorrectly calculates the shift to the left, but only for the abutment 2 bearing seat offsets. Other calculations that are affected include the width of the cheekwalls, the length of horizontal cheekwall reinforcement bars, and the number of vertical reinforcement bars in the cheekwalls.

While verifying the calculations for the patch it was discovered that the sole plate thickness was not being set before making the calculations of the bearing seat offsets and the calculations of the membrane waterproofing quantity. This has been corrected. This change affects the bearing seat offsets for both abutments 1 and 2. The changes to the bearing seat offsets due to this error were very small, in the third decimal place (for example, 0.003). The change in the membrane waterproofing quantity due to this error could add additional square yards to this quantity.

For abutment 2 only, manually calculate the bearing seat offsets, width of the cheekwalls, length of horizontal reinforcement and number of vertical reinforcement bars in the cheekwalls, and update the drawings. For abutment 1, the change to use the correct sole plate thickness in the bearing seat offset calculations produces negligible differences, thus the bearing seat offsets for abutment 1 should not have to be manually recomputed. For adjacent box beams bridges with wall abutments, manually calculate the membrane waterproofing quantity.

A fix for this problem is available in version 3.1.3.2. This version can be downloaded as a patch from the BRADD website.
