# PENNDOT e-Notification

## BRADD

No. 015

## Problem with Deck Transverse Reinforcement

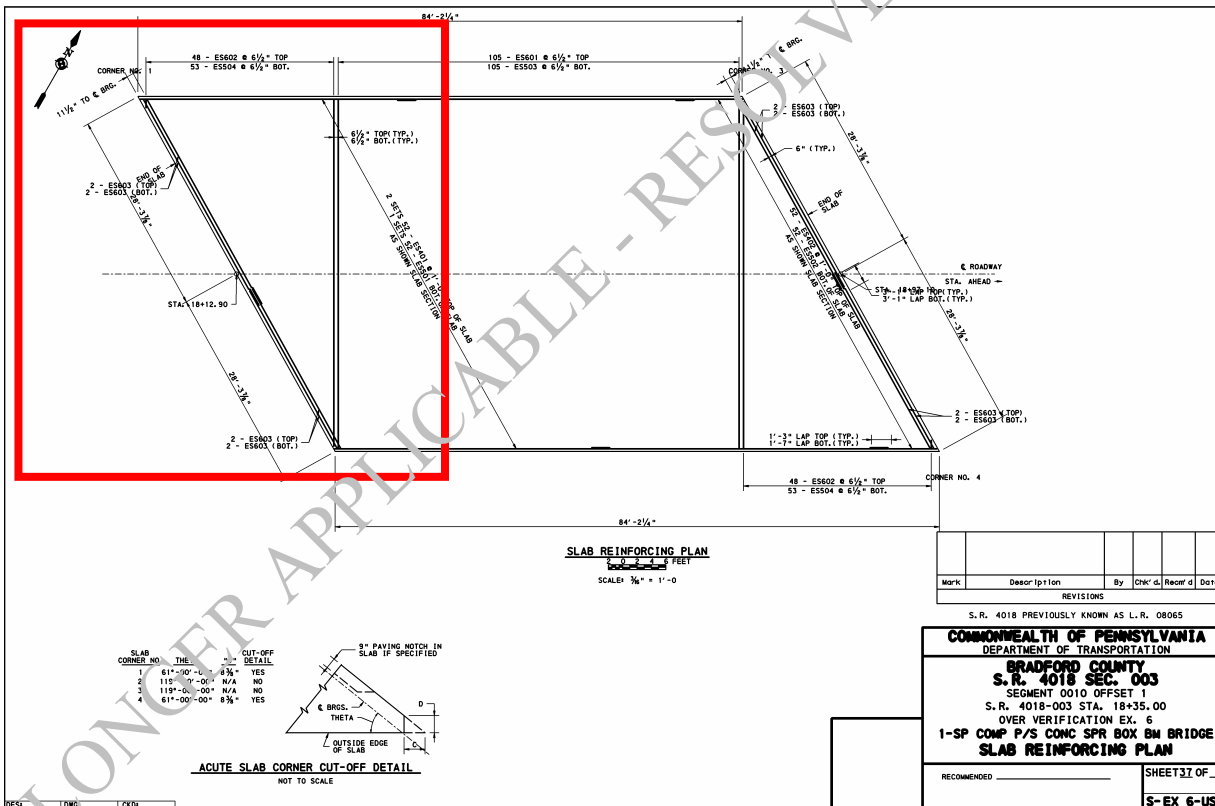
BRADD has an error when calculating the number of and the lengths of the rebars required in the acute corners of the slab reinforcing plan for spread beam superstructures. This problem only occurs for tangent decks with a skew angle less than 75 degrees. An example slab reinforcing plan demonstrating this problem is shown below, followed by a close-up of the corner at abutment 1.

- Recalculate and modify the number of bottom slab bars in the acute corners of the slab and modify both the slab plan and superstructure reinforcement schedule.
- Recalculate and modify the length of the top slab bars in the acute corners of the slab and modify the length shown in the superstructure reinforcement schedule.
- Recalculate the total reinforcement computed by BRADD based on the above two calculations.

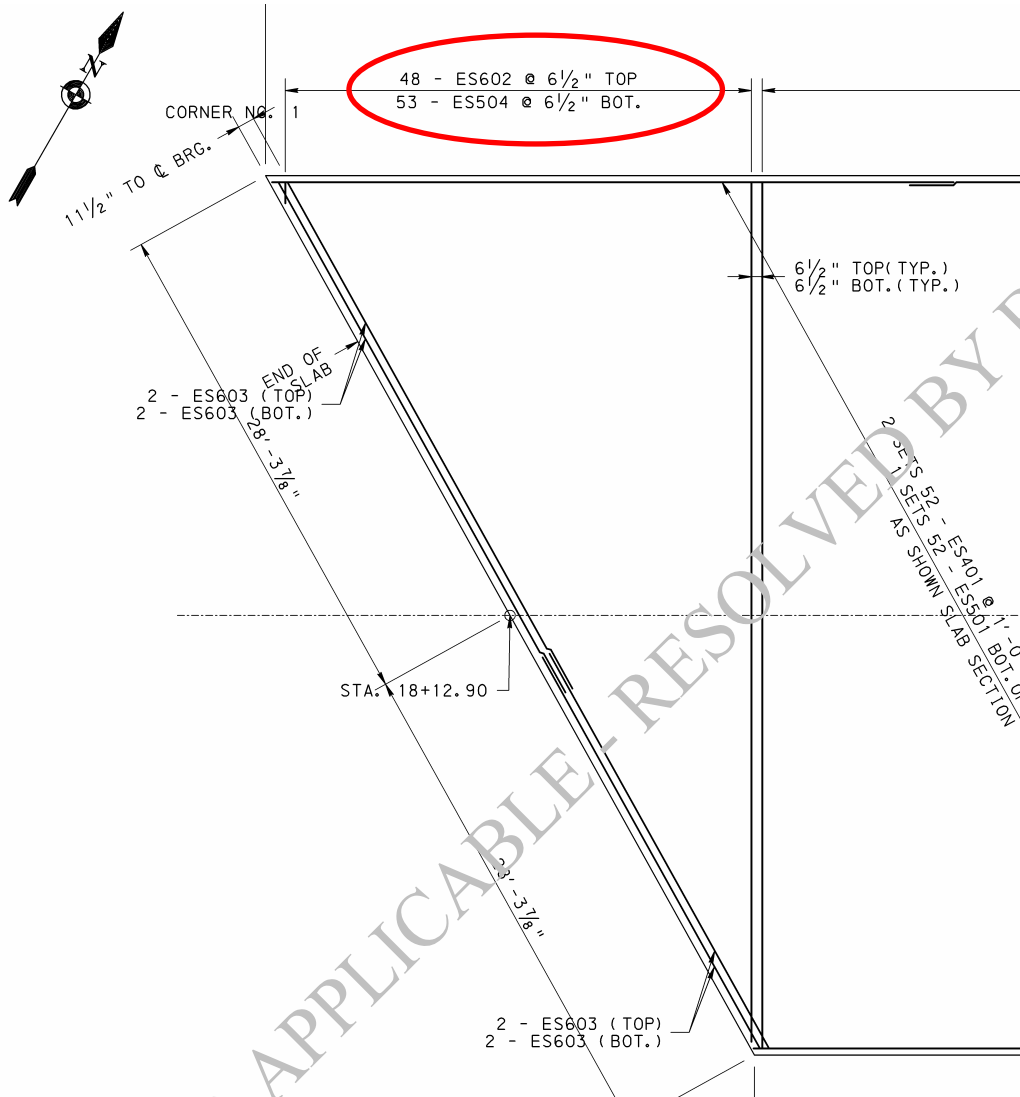
The rebar labeled "ES504" in the above detail has the number of rebars computed incorrectly. The number should match that of the top bars (48) which are computed correctly. For this example, the spacing of the top and bottom bars is the same. Regardless of whether the spacings are the same or different, the user will need to recalculate the number of bottom bars and their lengths, and then change the reinforcement bar chart accordingly. These same bars are also placed in the other acute corner of the slab reinforcing plan at abutment 2.

In addition to the bottom bar corrections, the length calculation for the top rebar (ES602 shown in the example) is incorrect and must be recalculated by the user. The length as reported in the rebar chart for this example is shown below.

The length should be shown for this example as a varying bar with 2'-2" as the minimum length. The maximum value is correct. The "B" leg of the bar varies from 1'-6" to 47'-5 1/8". The correct calculation for this example would show in the reinforcement chart as the following.
