**Bureau of Design  
Engineering Computing Management Division**

**BRADD**

No. 026  
February 12, 2010

**Work Point Coordinates for Superstructures With  
Integral Abutments and Beam Offsets for  
Adjacent Box Beams**

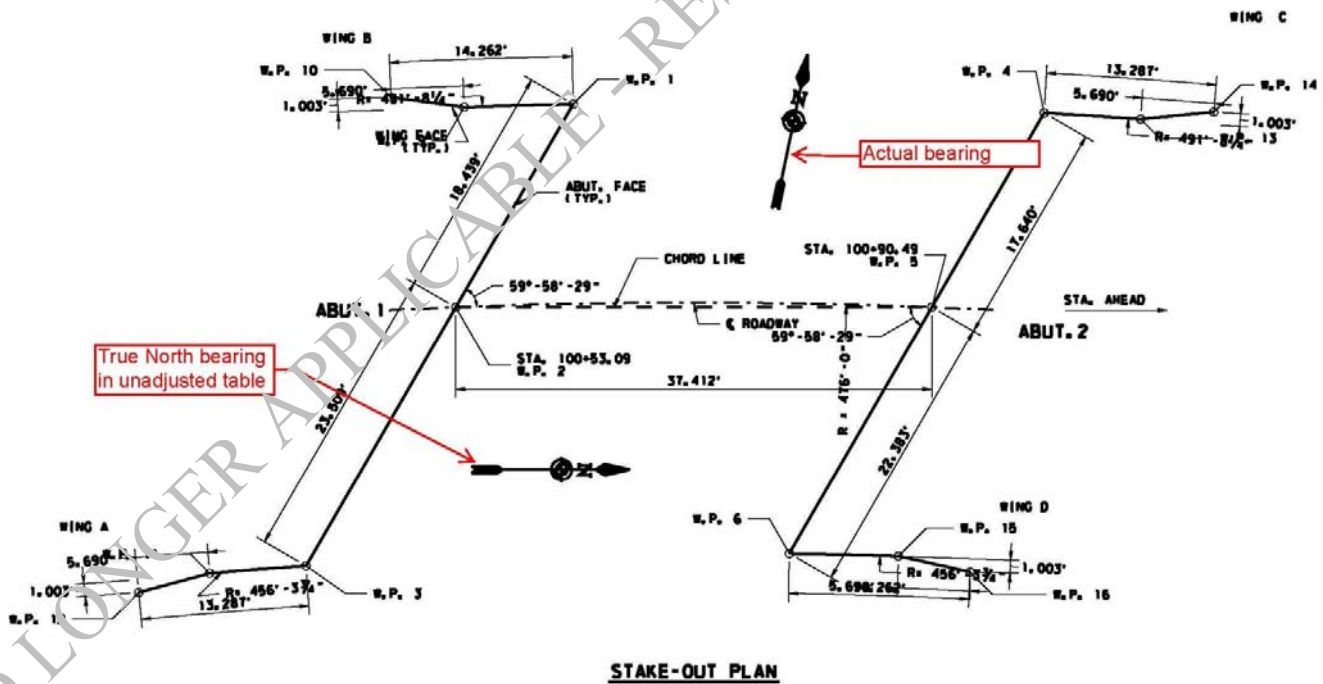
The work point coordinates for superstructures with integral abutments that appear on the stake out plan drawings were not being rotated to the bearing of the back tangent reference line. The station and offset workpoint values were correct.

All Coordinate values are suspect

The workaround for this problem is to manually rotate the workpoints shown on the table by the angle of the back tangent reference relative to true North, following the procedure in the BRADD Users Manual, section 3.2.4.2.

A fix for this problem is available in BRADD version 3.1.4.1. This version can be downloaded as a patch from the BRADD website.

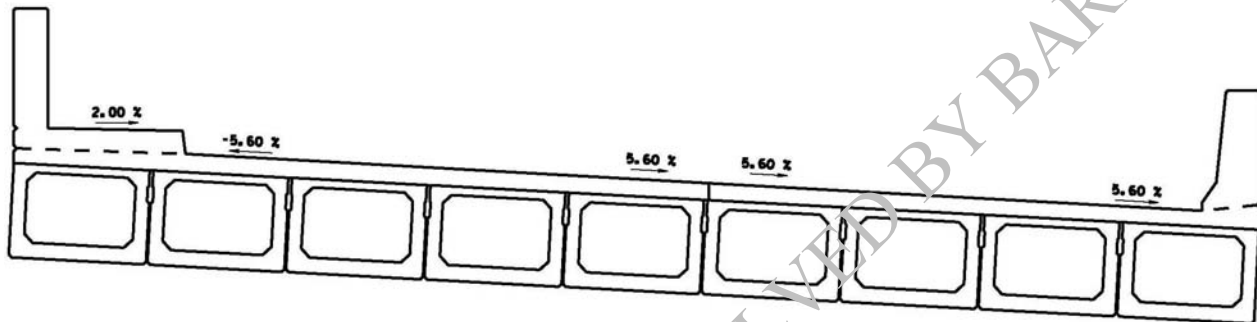
The beam offset dimensions were being calculated incorrectly on the left side of the deck for adjacent box beam superstructures with positive beam slopes (as specified in Section 7.2.3.6 of the BRADD Users Manual). A positive slope indicates that, looking ahead stations, the beam section has rotated clockwise, as shown in the cross-section below.

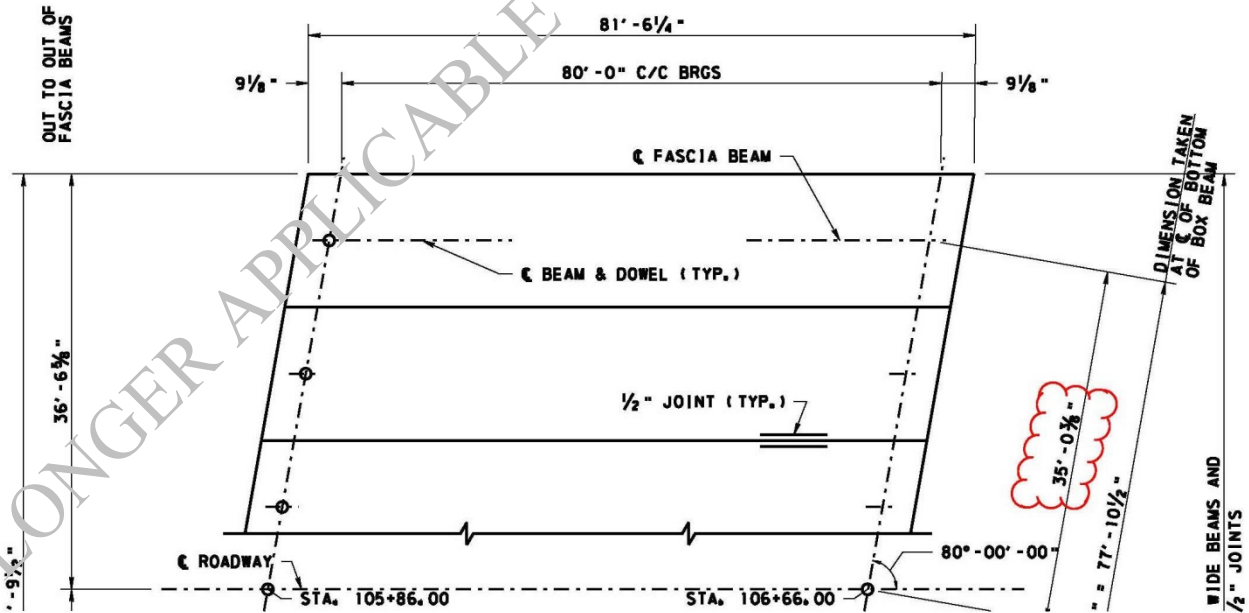
1. A mismatch between the offset value along the left side of the deck in the FRAMING PLAN detail and the Centerline Beam Offset value in the Abutment Bearing Seat Location And Elevation Table details. The values shown in the Abutment Bearing Seat Location And Elevation Table are correct.
2. This problem also affected the values shown in the Beam Offsets tables in the geometry output file, "Geometry.O1".
3. Also affected are the dimensions locating the centerline of beams in the Abutment Plan details.

The following partial Framing Plan detail shows the dimension referencing the centerline of beam 1 that was corrected by this patch.

There is no workaround, except to calculate the beam offsets manually and update the left beam offset shown in Framing Plan detail and the dimensions referencing the centerline of beam 1 in the Abutment Plan detail.

A fix for this problem is available in BRADD version 3.1.4.1. This version can be downloaded as a patch from the BRADD website.

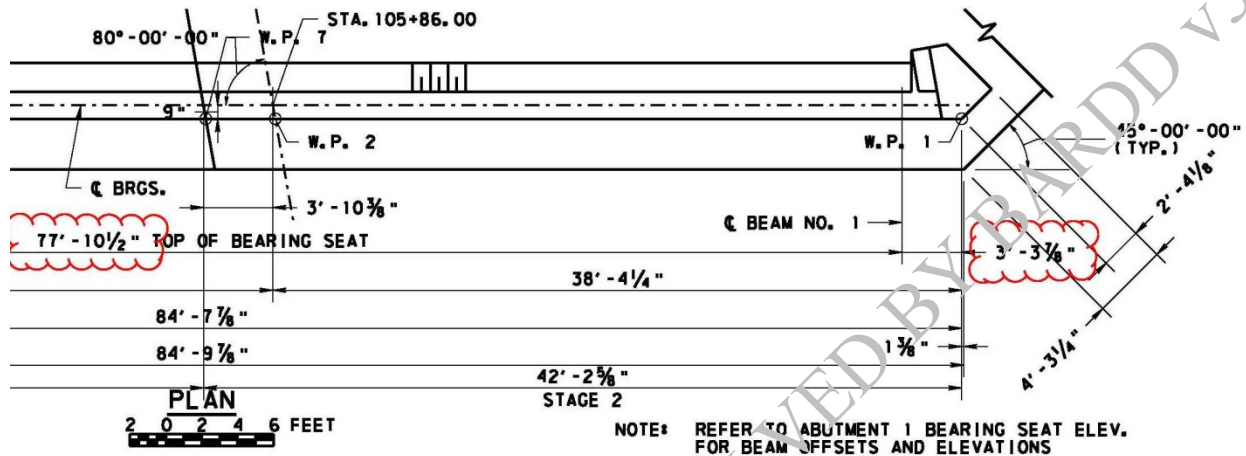
The following partial Abutment Plan detail shows the dimensions referencing the centerline of beam 1 that were corrected by this patch.
