**Bureau of Project Delivery
Bridge Design and Technology Division**

<p>BRADD No. 040 November 17, 2014</p>	<p>Integral Abutment: Incorrect Prestress I-Beam Stirrup Detailing</p>
---	---

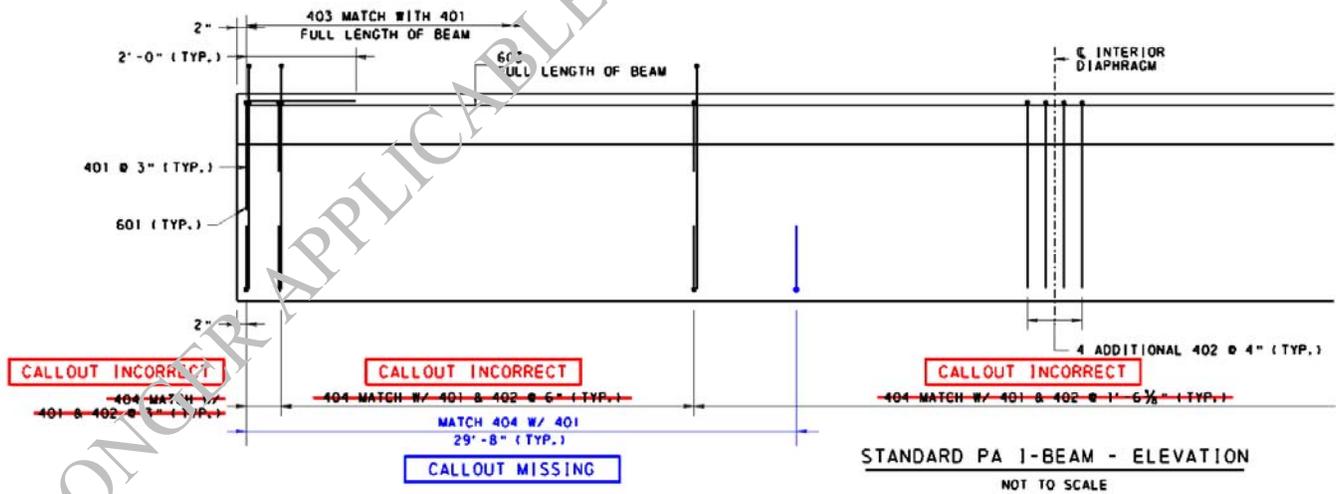
The labeling for the shear stirrup reinforcing is incorrect for Prestress I-Beams without a beam notch in the BRADD BEAM ELEVATION detail. This only occurs for bridges with Integral Abutments.

1. The 404 bars do not end at 1/3 span length.
2. The 401 and 402 bars are called out incorrectly.

The problems listed above occur only with Prestressed I-Beams *without* a beam notch for bridges with Integral Abutments.

A correct BEAM ELEVATION detail for a prestressed beam without a beam notch may be constructed by generating in BRADD a detail of a similar beam elevation *with* a beam notch and then manually copying the relevant stirrup detail information from the similar beam elevation detail with the beam notch to the beam elevation detail of the beam without the beam notch.

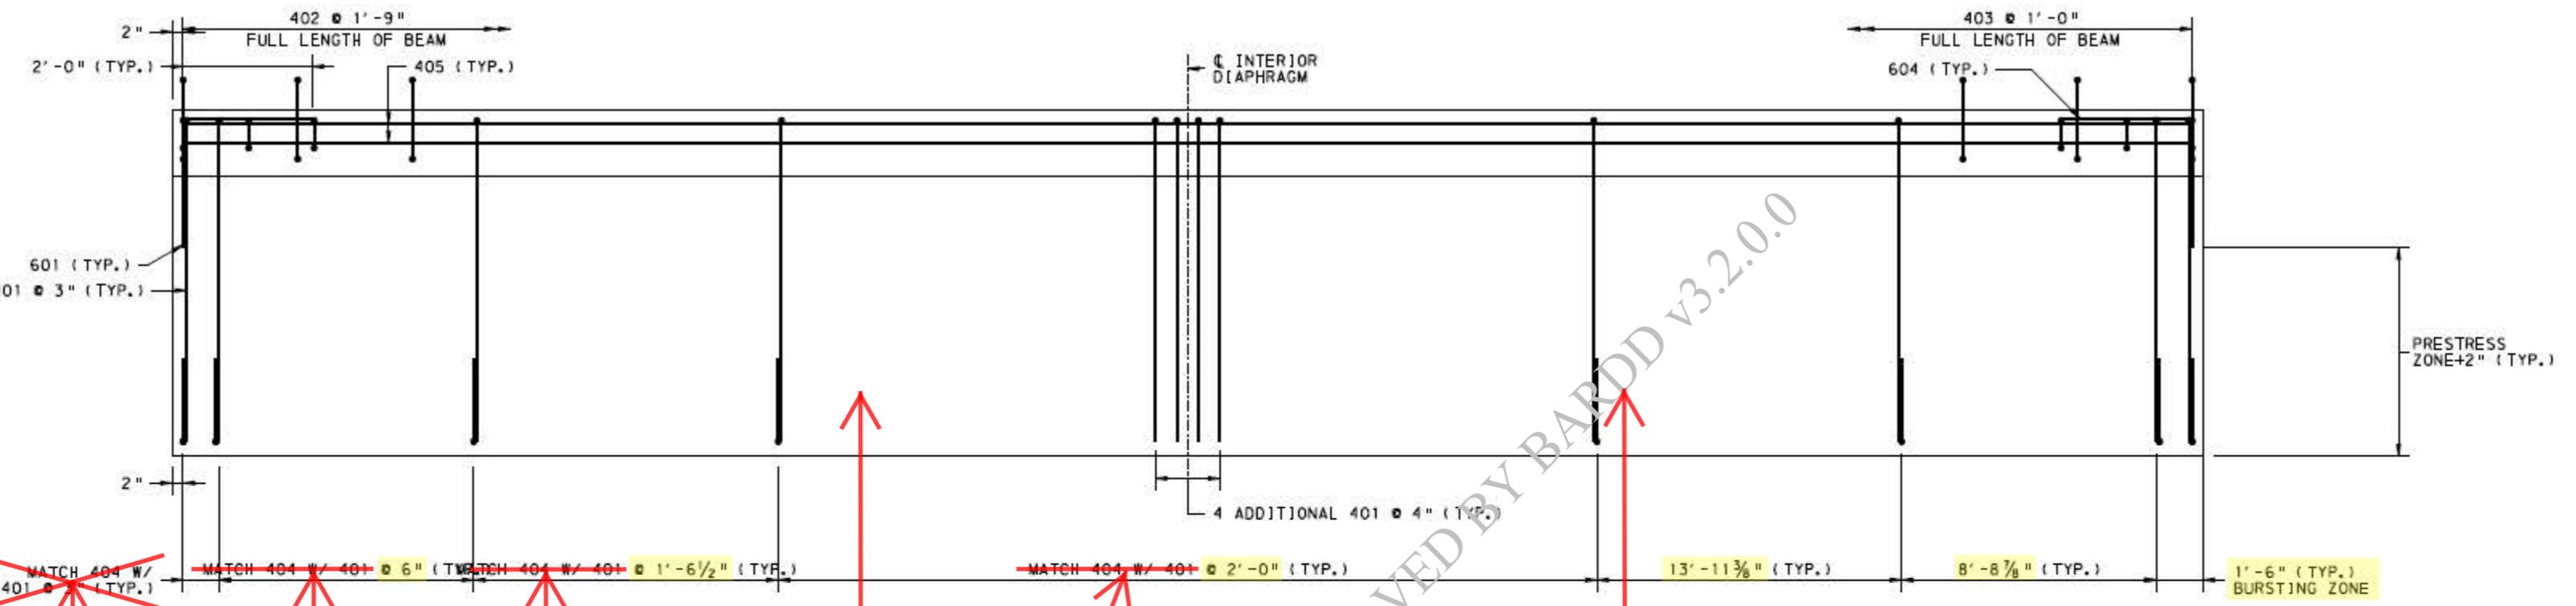
ORIGINAL JOB
STANDARD AASHTO TYPE I-BEAM - ELEVATION
 NOT TO SCALE

4. From the figures below, find the sheet with the beam type of interest (either PA I-Beam, AASHTO I-Beam or PA Bulb-Tee Beam). The top of each sheet shows an example of a BEAM ELEVATION detail containing the incorrect stirrup information (labeled ORIGINAL JOB). The bottom of each sheet shows an example of a BEAM ELEVATION detail created from the same job but with Superstructure Only option (labeled MODIFIED SUPER ONLY JOB). In each figure, items crossed out with red lines are incorrect. Items highlighted in yellow are correct.

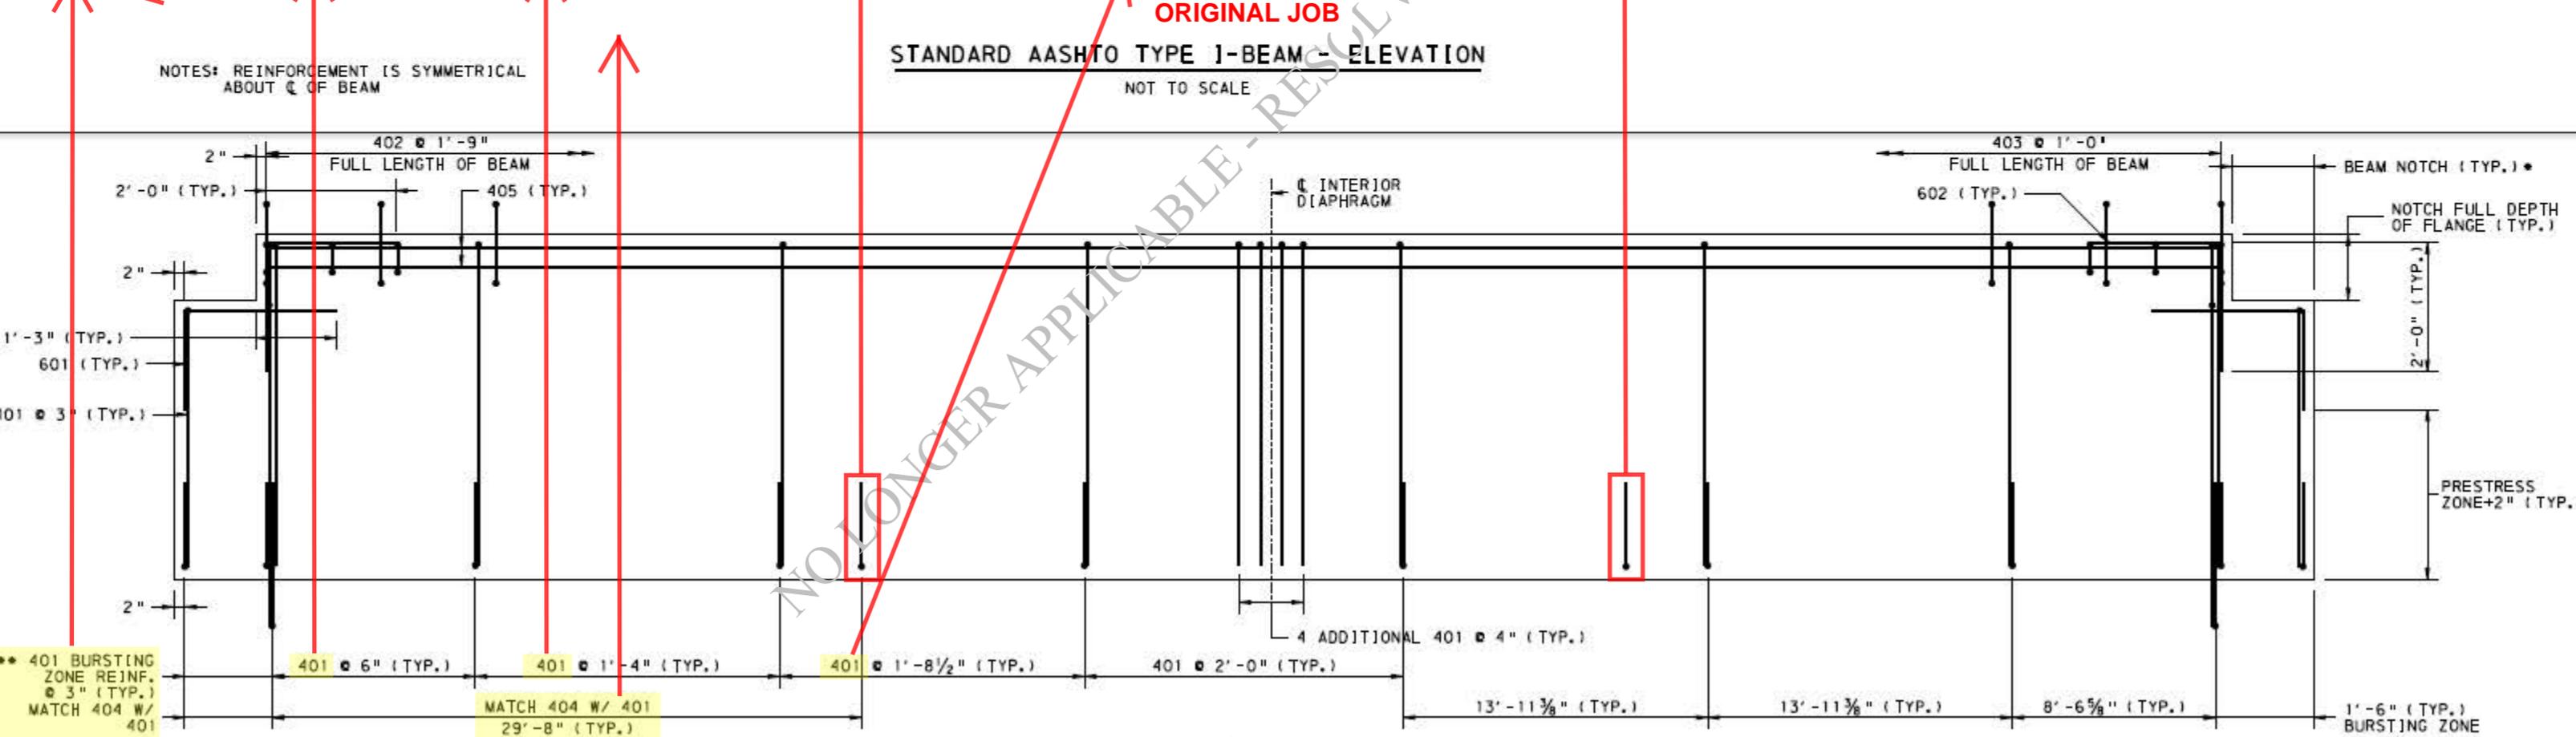
MODIFIED SUPER ONLY JOB
STANDARD AASHTO TYPE I-BEAM - ELEVATION
 NOT TO SCALE

** 401 BURSTING ZONE REINF. @ 3" (TYP.) MATCH 404 W/ 401

5. Copy or replace the items indicated in the attached example that matches the type of I-beam of interest.
