## Bureau of Project Delivery Bridge Design and Technology Division

No. 043  
November 24, 2015

### BRADD v3.2.2.0: Unable to Design Shallow Adjacent Box Beams – Patch Available

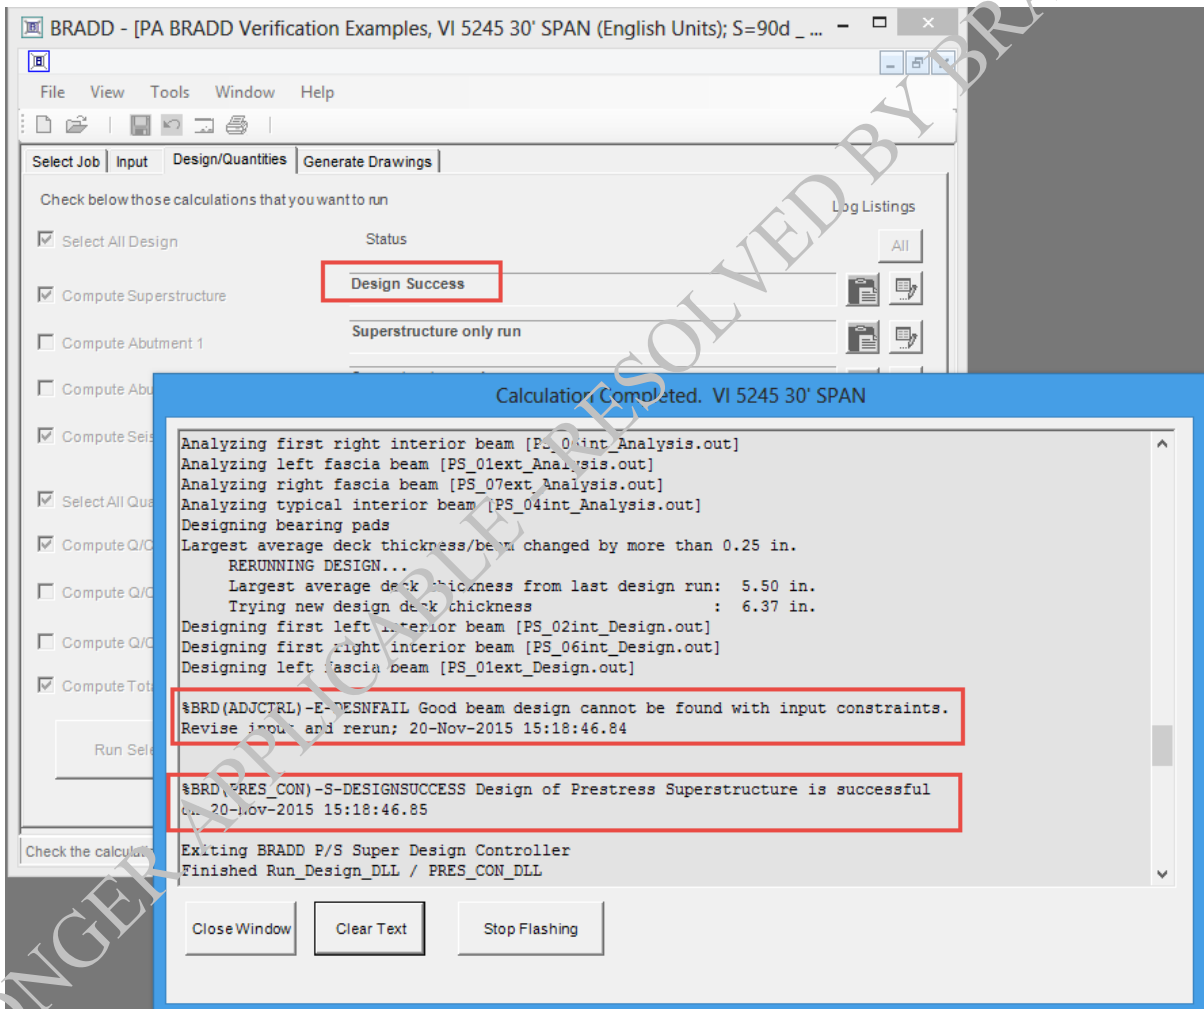
In addition the Design Status shown on the BRADD Design/Quantities Tab incorrectly indicates that a Successful Design was found.

A fix for this problem is available in BRADD patch version 3.2.2.1 which can be downloaded as a patch from the BRADD website. This patch employs a workaround of always setting the PSLRFD CTL Command / Overhang to Beam Depth Override to 'Y' for Adjacent Box Beams. This allows PSLRFD to design the shallow adjacent box beams, however the erroneous warning message will still appear and should be ignored because it is incorrect.
