**Bureau of Project Delivery
Bridge Design and Technology Division**

BRADD

No. 048
March 9, 2018

BRADD v3.2.4.0: Integral Abutments w/ Staged Construction; Abutment Details, Barrier Overhangs Abutment – Patch Available

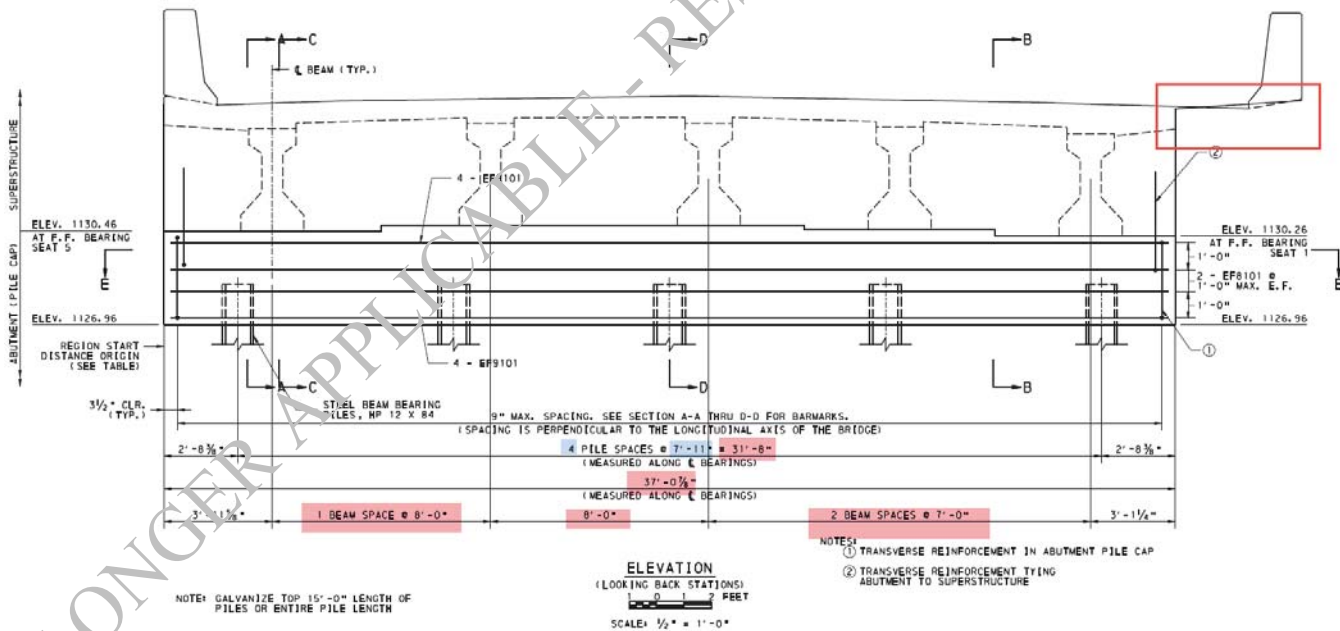
Under certain conditions BRADD version 3.2.4.0 details some integral abutment details incorrectly. For a skewed bridge with integral abutments and a staged construction joint with different beam spacings, BRADD incorrectly details the abutment length perpendicular to the C.L. of bridge instead of parallel to the C.L. of bearing. As a result, on the “Abutment Elevation” detail, the right barrier is detailed overhanging the right end of the abutment and the beam spacings shown are incorrect.

The details shown below were taken from a BRADD job with a 60 degree skew.

A fix for this problem is available in BRADD patch version 3.2.4.1 which can be downloaded for free as a patch from the BRADD website.

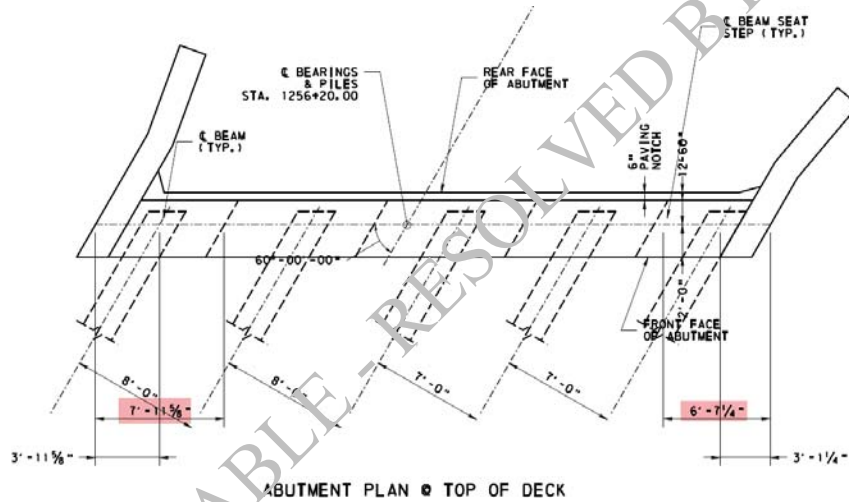
The overall dimension of the abutment length (measured along the CL Bearing) needs to be revised and some dimensions shown on the “Abutment Plan @ Top of Deck” detail, and the “Pile Cap Transverse Reinforcement Information” table are also impacted. The user input of Number of Piles and Pile Spacing will need to be adjusted accordingly. These pile spacings are displayed on a number of details.

The beam spacing has not been expressed along the C.L. Bearing and all the highlighted numbers above (between the two fascia beams) need to be increased by a factor of 1.155 ($1 / \sin(60^\circ)$)

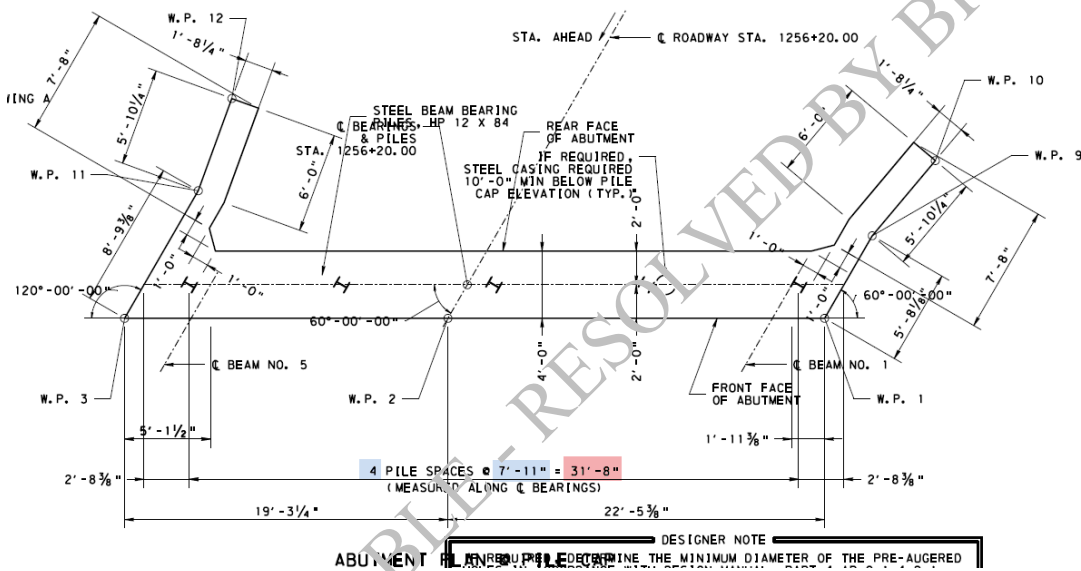
The overall pile spacing dimensions (measured along the C.L. Bearing) shown on the “Abutment Plan @ Pile Cap” detail also needs to be revised.

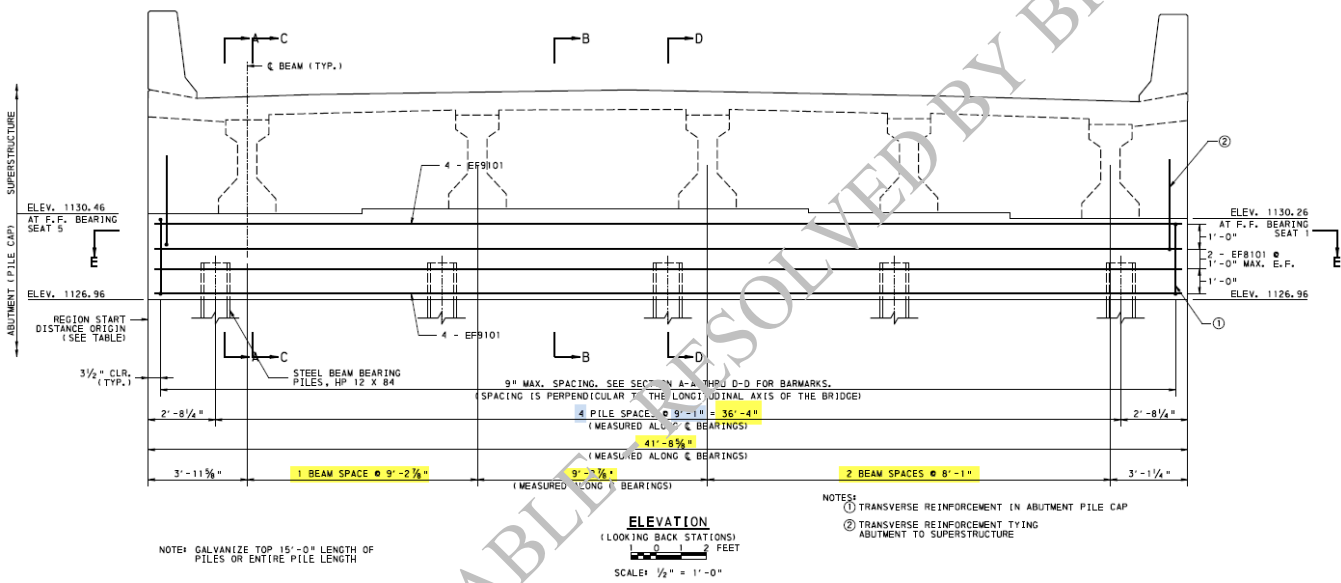
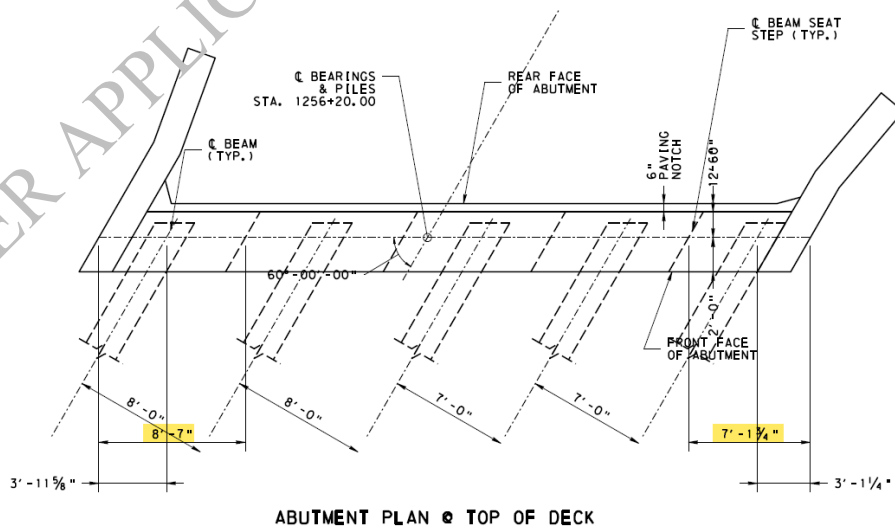
The details shown below display the corrected dimensions:
