**Bureau of Project Delivery
Bridge Design and Technology Division**

BRADD

No. 049
May 4, 2018

**BRADD v3.2.4.0: Pile Cap Depth Too Large for One
Integral Abutment – Patch Available**

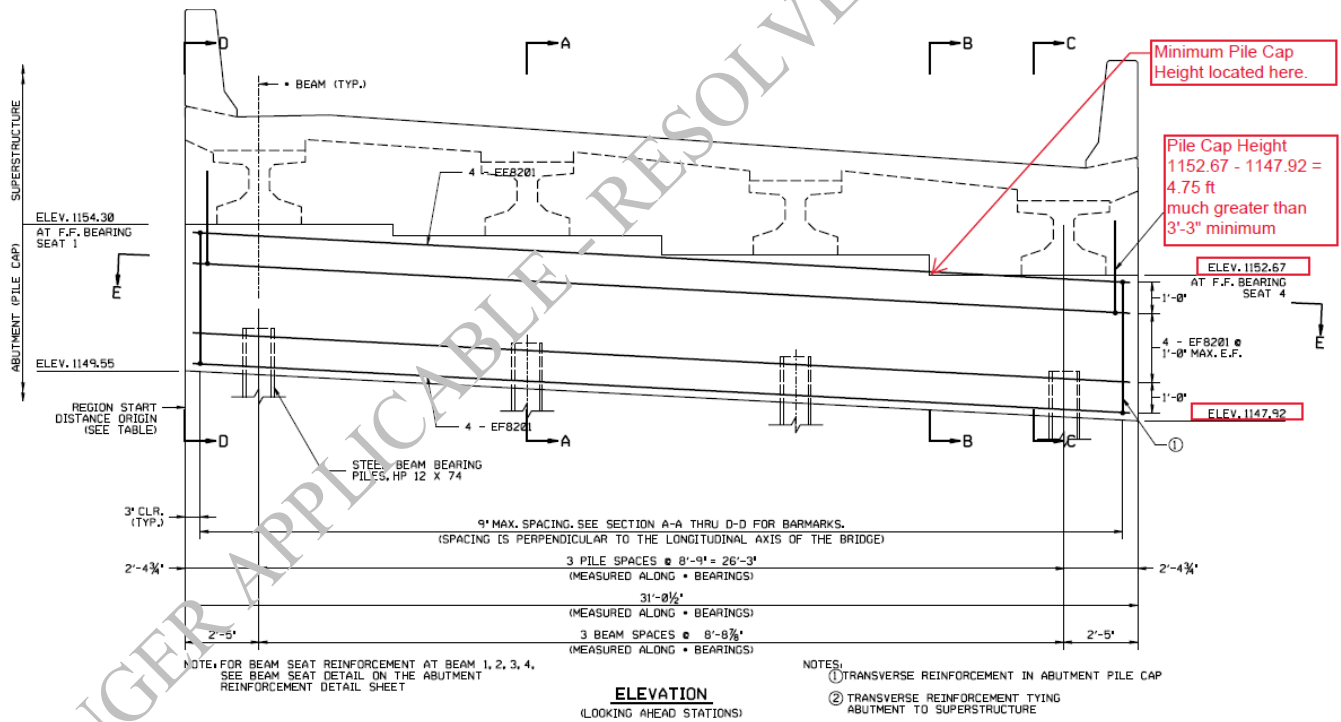
For bridges that have integral abutments and a full super elevation cross-section above the integral abutment, the height of the pile cap that is calculated is too large (the minimum pile cap height exceeds 3'-3"). This problem only occurs when the bottom of the pile cap is sloped downwards (left-to-right, facing the abutment) and usually only occurs at one of the integral abutments.

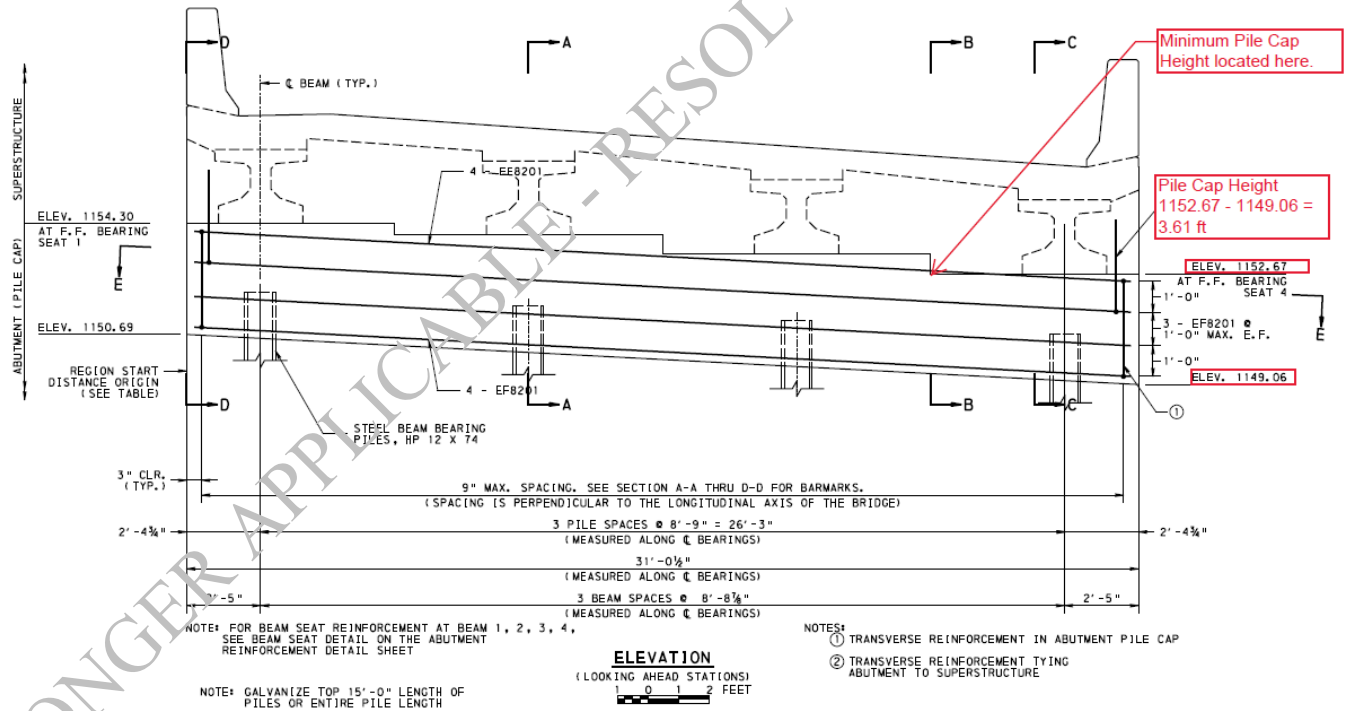
The following shows the integral abutment elevation that is created after the patch has been installed.

A fix for this problem is available in BRADD patch version 3.2.4.2 which can be downloaded for free as a patch from the BRADD website.
