**Bureau of Project Delivery
Bridge Design and Technology Division**

<p>BRADD No. 040 November 17, 2014</p>	<p>Integral Abutment: Incorrect Prestress I-Beam Stirrup Detailing</p>
---	---

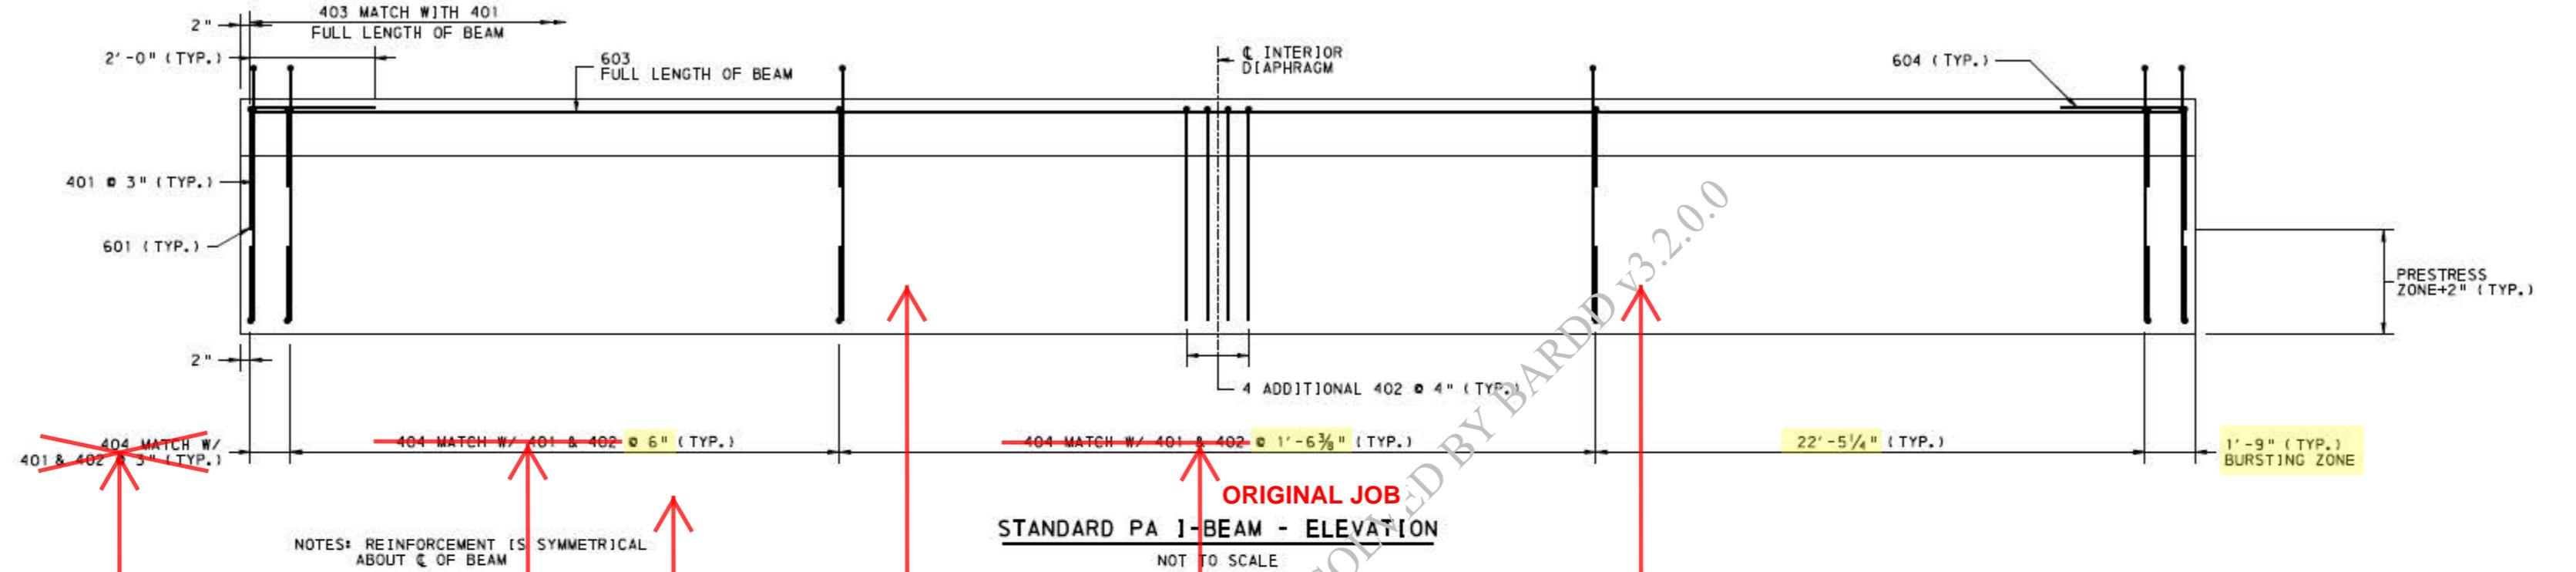
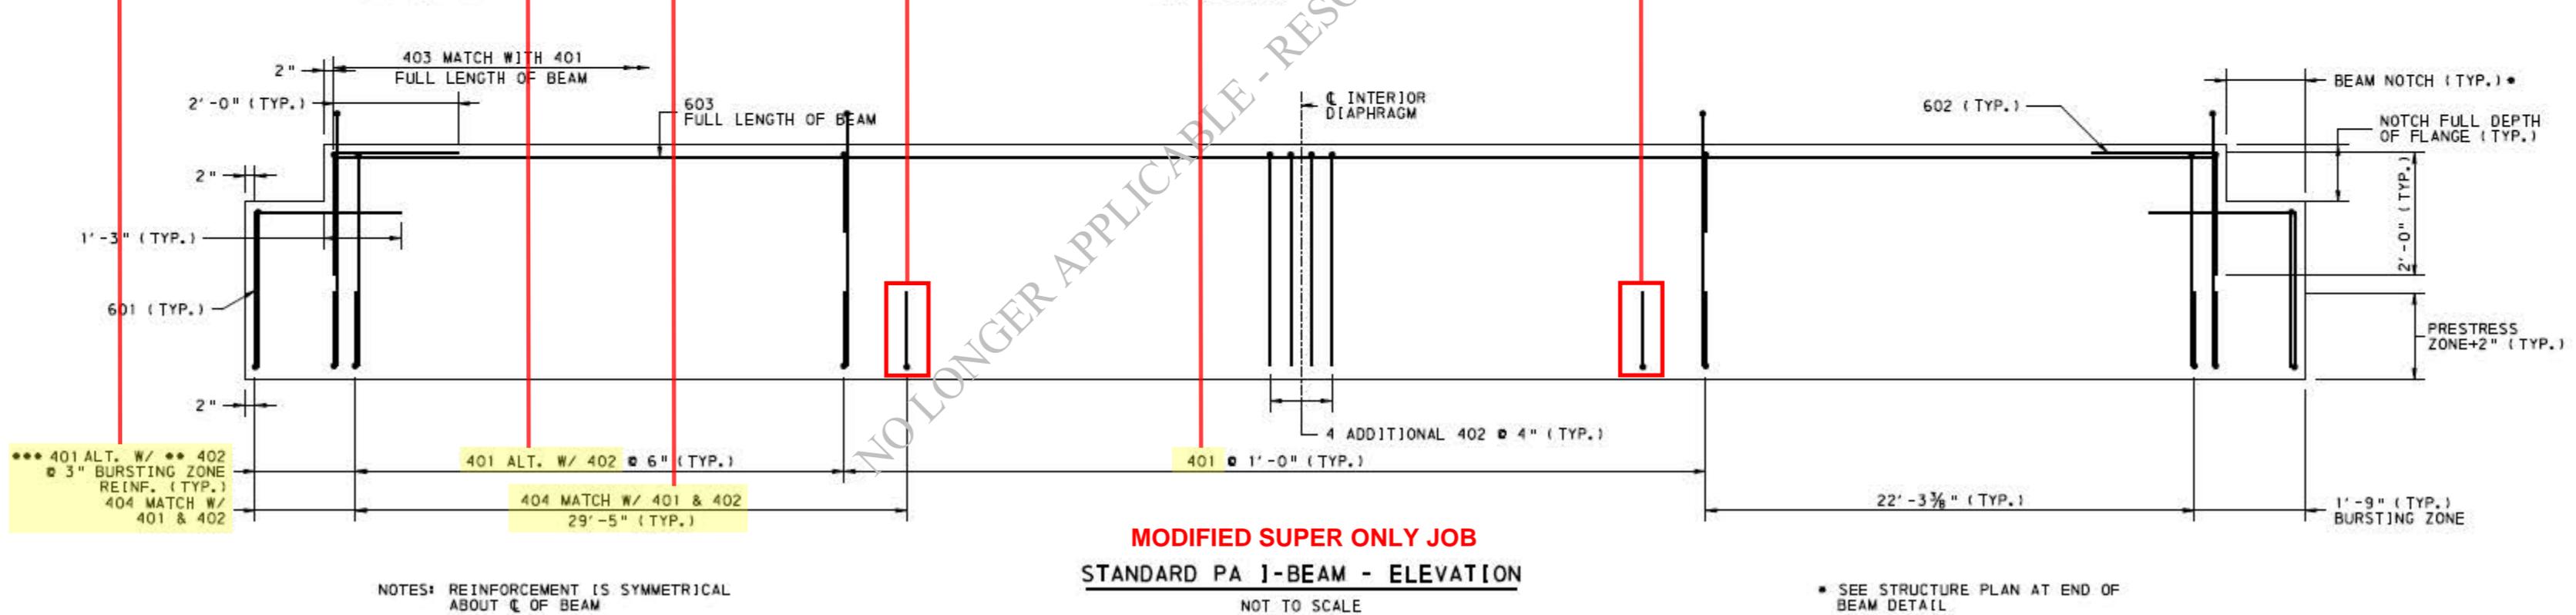
ORIGINAL JOB
STANDARD AASHTO TYPE I-BEAM - ELEVATION
 NOT TO SCALE

The labeling for the shear stirrup reinforcing is incorrect for Prestress I-Beams without a beam notch in the BRADD BEAM ELEVATION detail. This only occurs for bridges with Integral Abutments.

1. The 404 bars do not end at 1/3 span length.
2. The 401 and 402 bars are called out incorrectly.

5. Copy or replace the items indicated in the attached example that matches the type of I-beam of interest.
