**Bureau of Project Delivery
Bridge Design and Technology Division**

BRADD

No. 048
March 9, 2018

BRADD v3.2.4.0: Integral Abutments w/ Staged Construction; Abutment Details, Barrier Overhangs Abutment – Patch Available

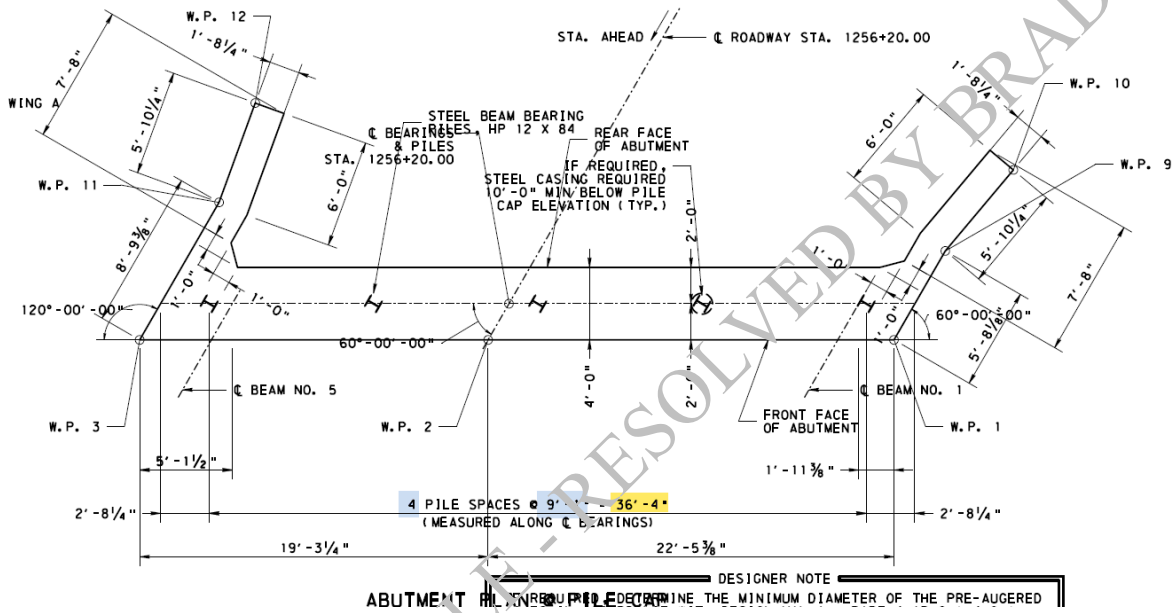
The overall dimension of the abutment length (measured along the CL Bearing) needs to be revised and some dimensions shown on the “Abutment Plan @ Top of Deck” detail, and the “Pile Cap Transverse Reinforcement Information” table are also impacted. The user input of Number of Piles and Pile Spacing will need to be adjusted accordingly. These pile spacings are displayed on a number of details.

There is no workaround available because the calculations within the BRADD software are incorrect.
